LEAP and TEM of GaN HEMTs

Blake Darby, Ray Holzworth, Dr. Nicholas
Rudawski, Dr. Kevin S. Jones

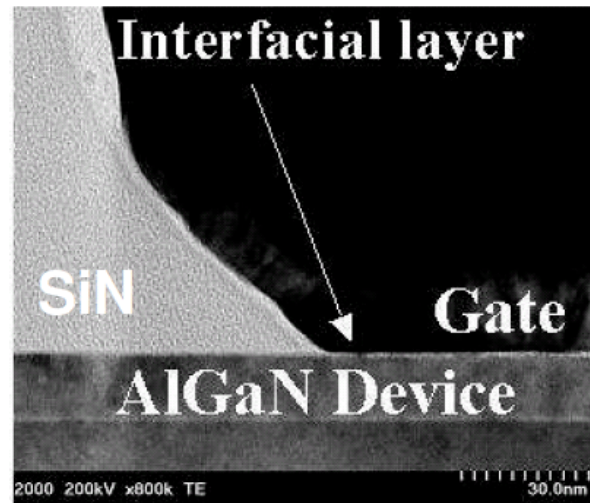
- Nitronex has reported that a very thin ($< 50\text{\AA}$) interfacial layer between the Gate and AlGaN negatively affects reliability.¹

- Devices with a reduction of this layer show improved reliability.¹
- The composition of this layer and its origin are unknown.
- The layer is too thin to identify by TEM.
- New Approach: LEAP may be able to determine the atomic composition of this layer leading to methods to more effectively control its formation and width.

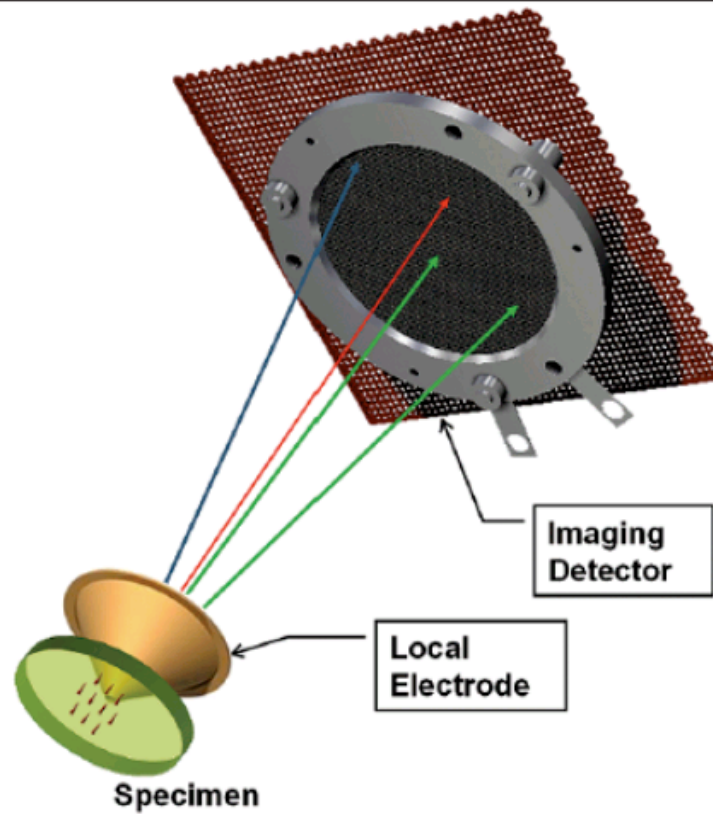
Local Electrode Atom Probe

What is LEAP?

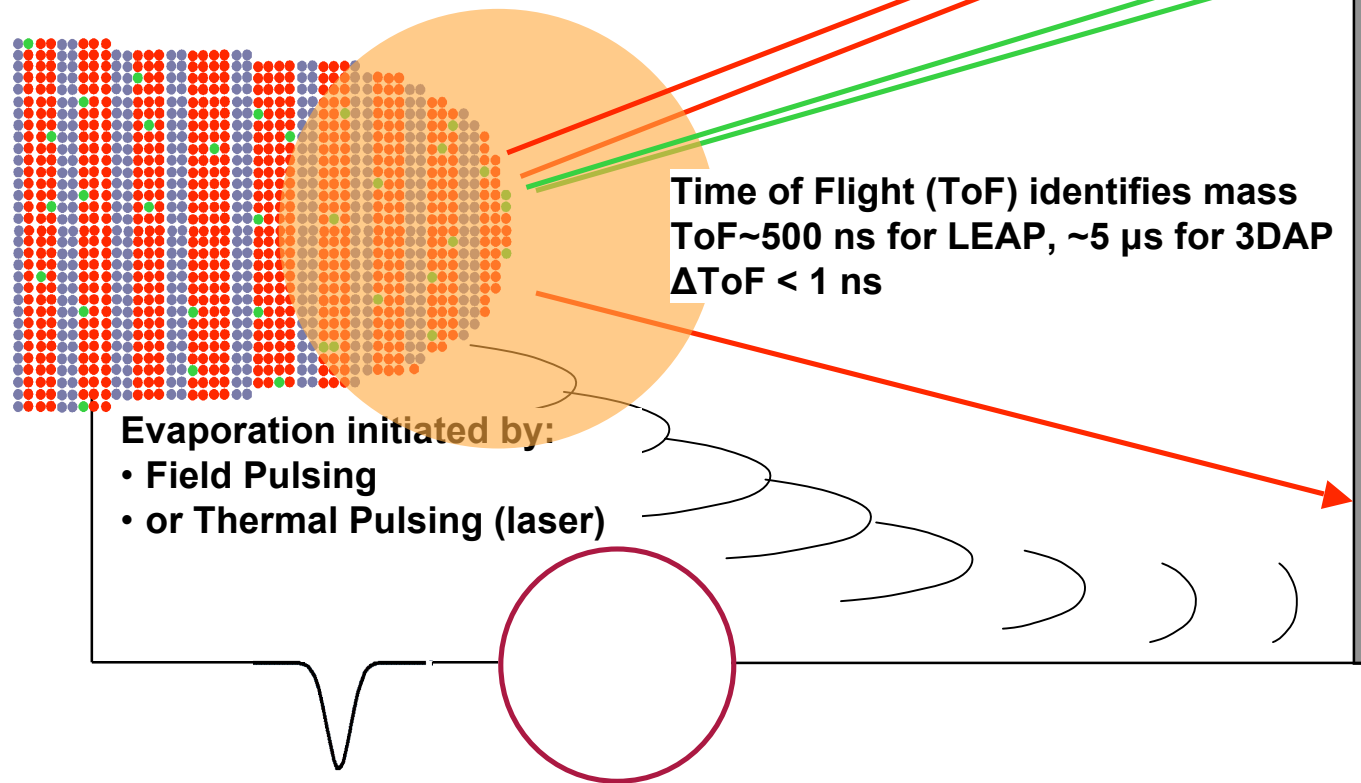
Atom Probe Operation

~50nm tip → 50mm detector = 10^6 magnification

2D Detector

Determines x,y coordinates of atom

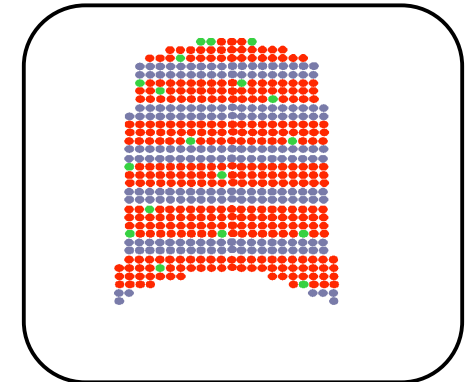
3-Dimensional Reconstructed Model of Specimen

Data are collected and interpreted

z is determined from sequence of evaporation events

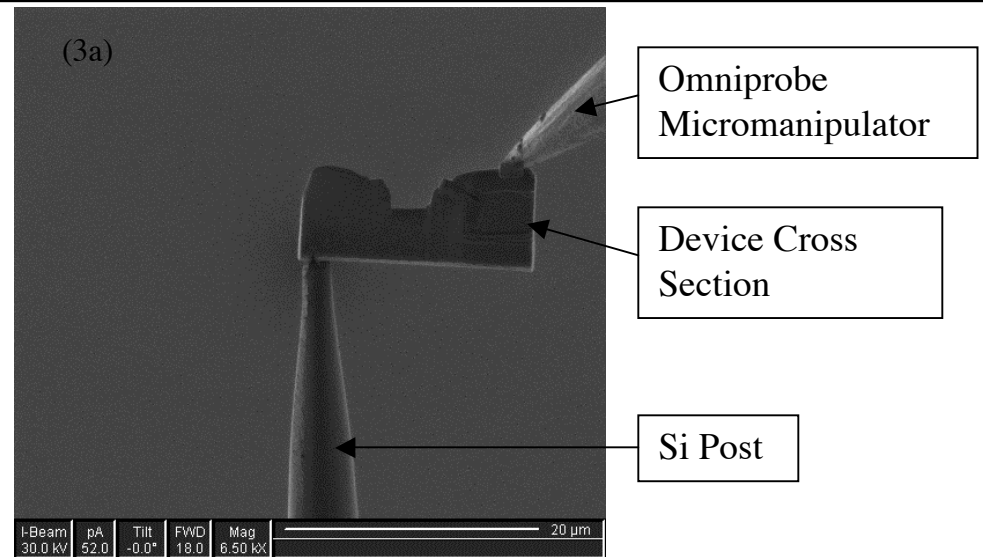
- 1) FIB device cross section
- 2) Sample lift out
- 3) Mount on silicon post
 - a) Attach to post

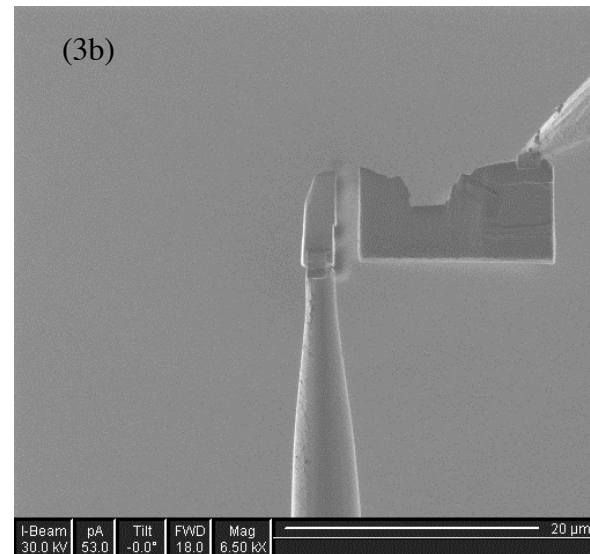
- b) Detach from cross section

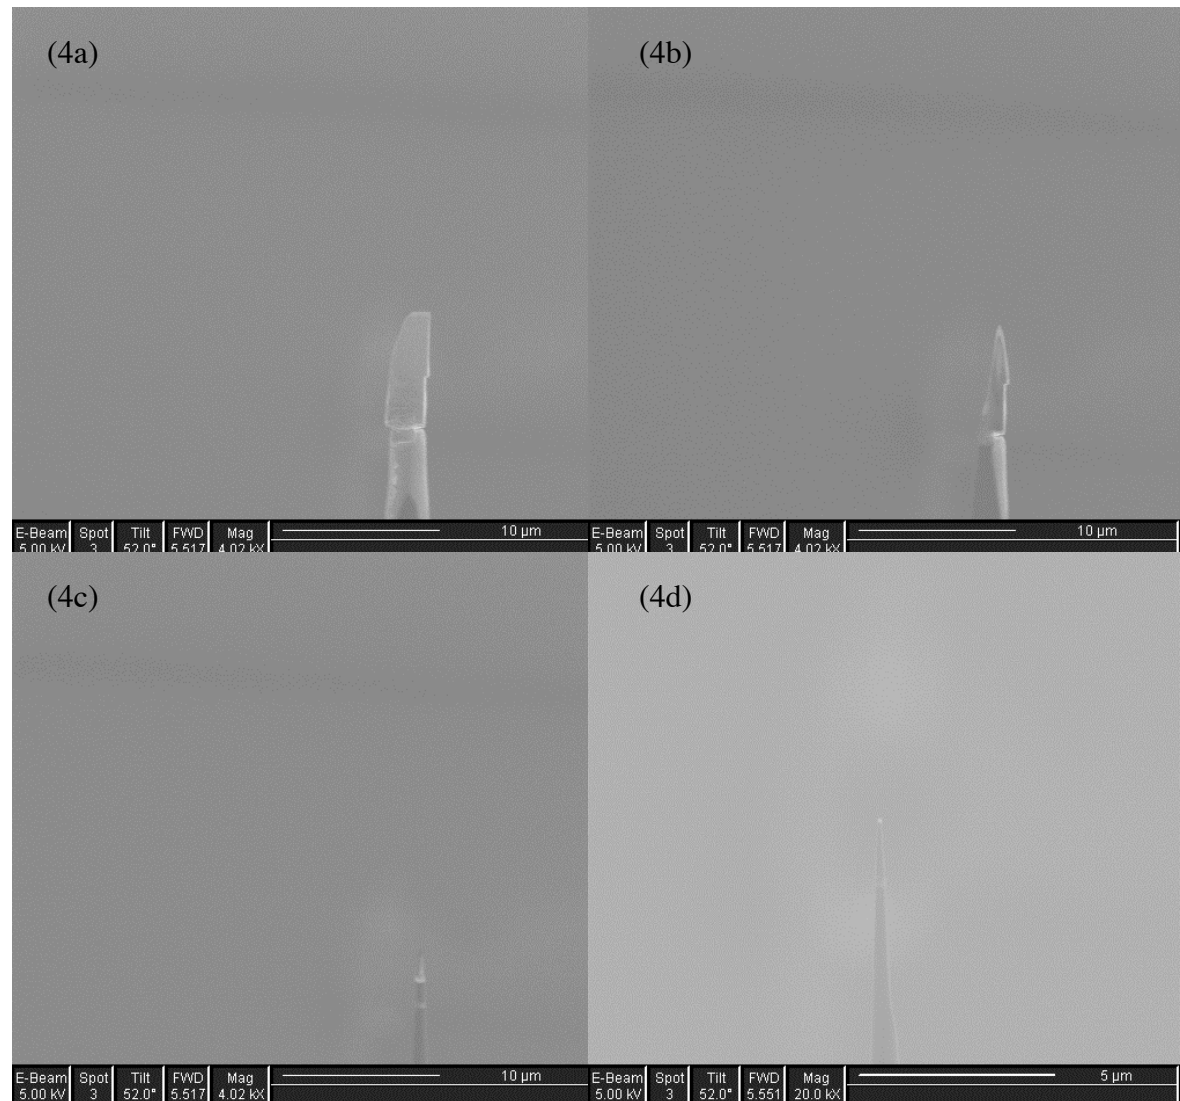
Constructing LEAP tips

- 1) FIB device cross section
- 2) Sample lift out
- 3) Mount on silicon post
- 4) Sharpen tip

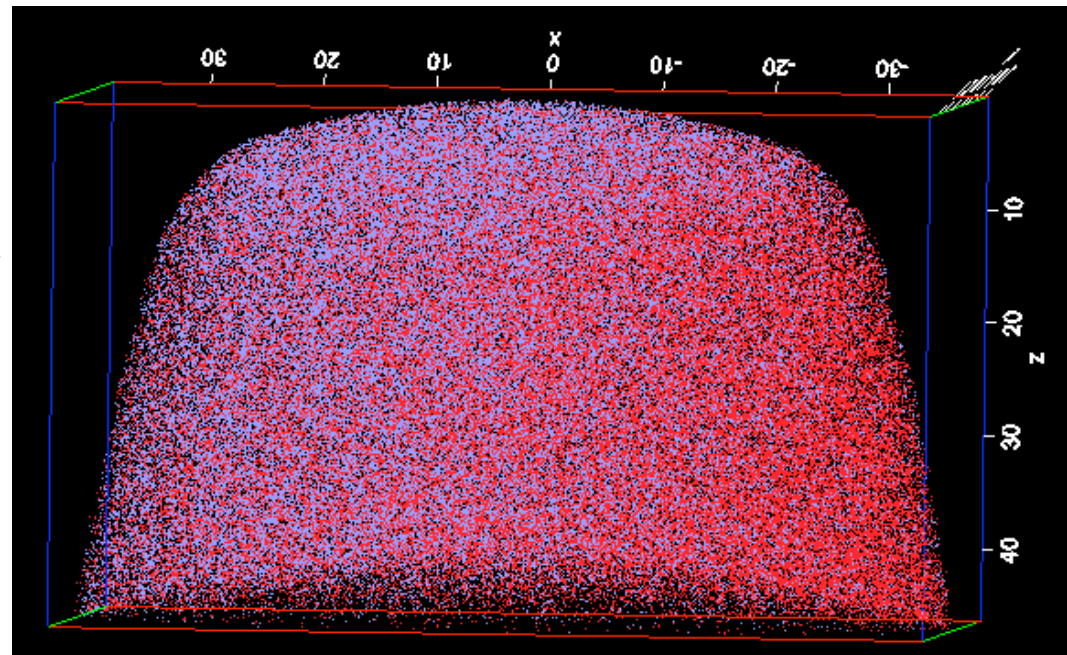
Preliminary LEAP Analysis

- First ever reported LEAP image from GaN
- Demonstrates that GaN can be analyzed by LEAP despite low conductivity
- 78,000,000 Atoms collected from this run
- Sample was run last week
- Data reconstruction and analysis still in progress
- LEAP reconstruction under gate

■ Ga
■ N

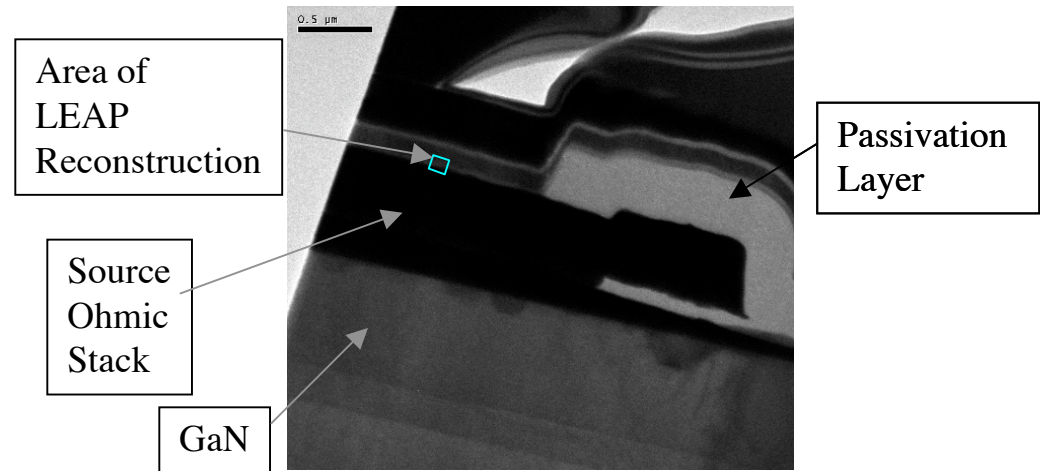
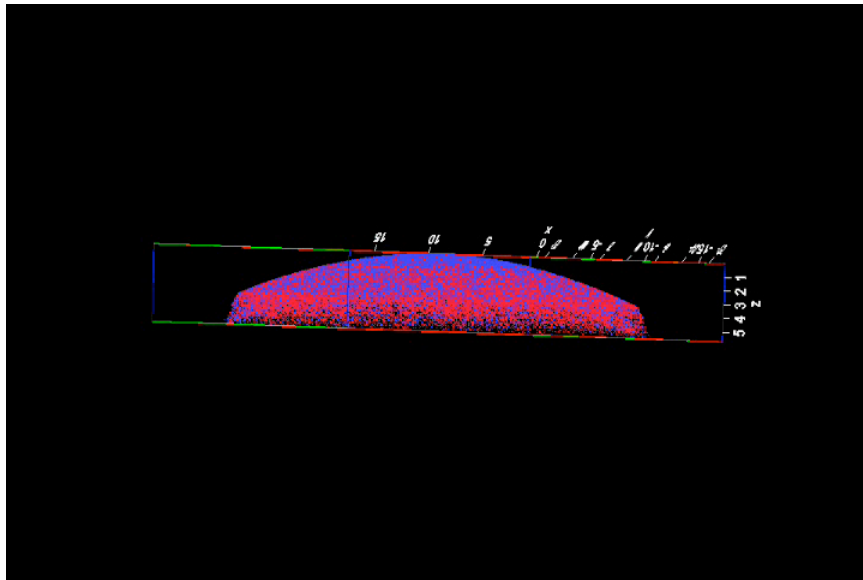
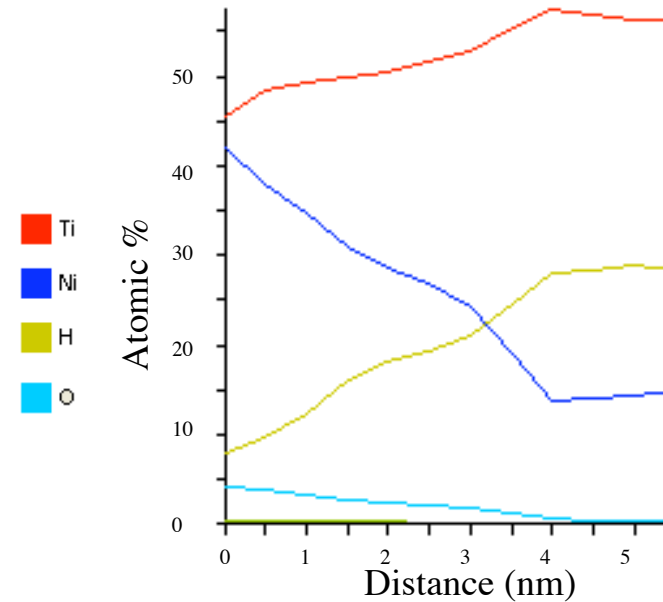
Preliminary LEAP Analysis

- LEAP reconstruction of part of the source ohmic contact stack
- Sample was run last week
- Data reconstruction and analysis still in progress

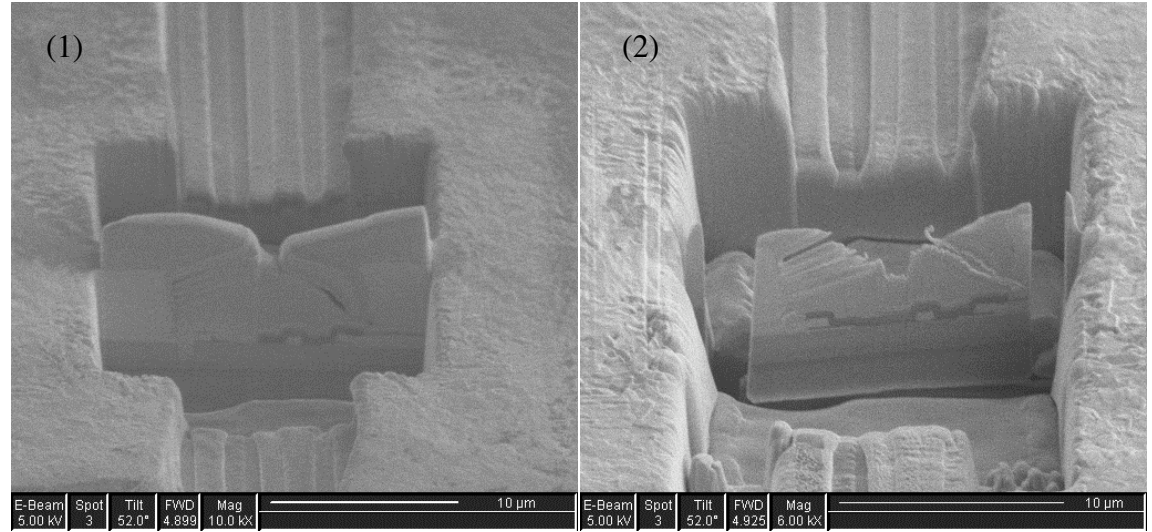
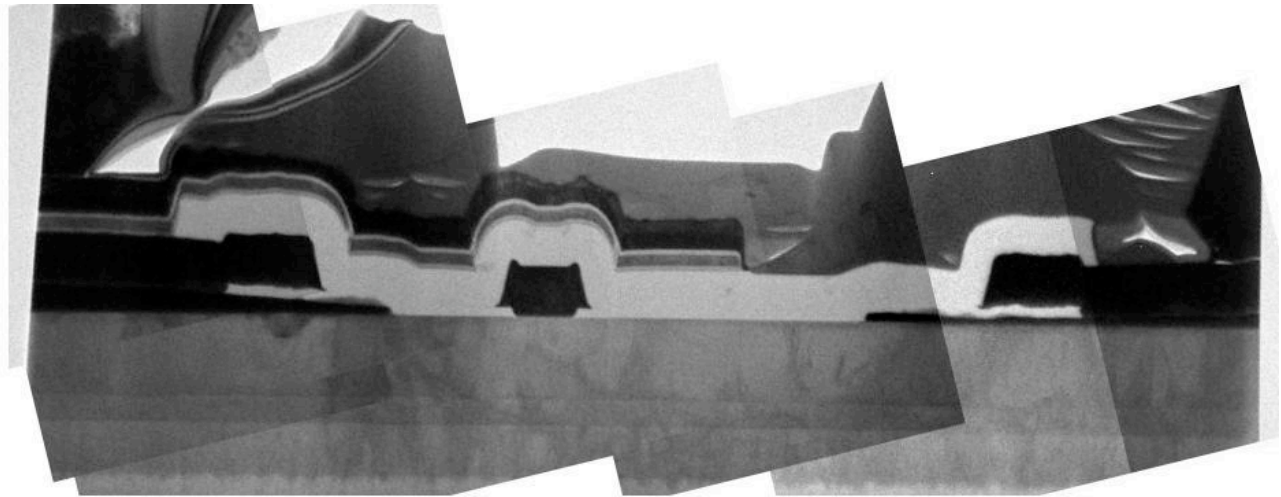
TEM Imaging

- Deprocessing procedure developed
- Site specific lift out procedure Developed for TEM
- Cross Sectional TEM imaging of devices in progress to further study structural changes
